A Review of Fundamental Shaft Failure Analysis

Abstract - This review paper gives the insights of various analysis carried out to find shaft failure. Roller Shaft failures can be optimized by preventive mechanical maintenance techniques & using safe design with proper manufacturing processes. The various literature has been systematically compared and reviewed to get a proper shaft failure analysis. Every method has its pros and cons and used by specific industrial segments. Shaft failure causes the unnecessary shutdowns and leads to heavy production loss. The objective of this paper is to study various shafts failure analysis and select the best method to find out the root cause failure of heavy nip roller shaft used in textile industry.

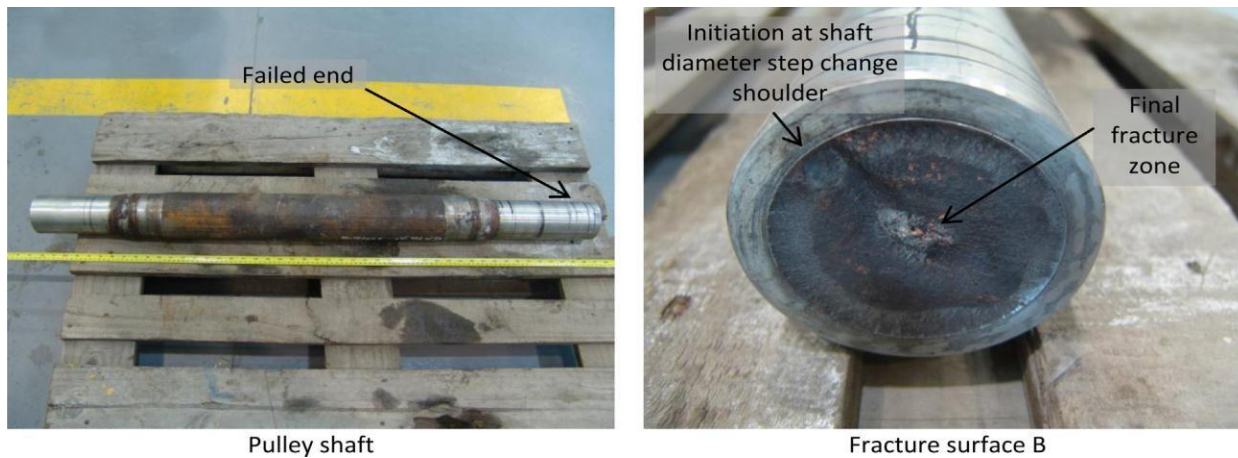
The macroscopic analysis of the shaft showed that the failure is of fatigue however closer microscopic examination revealed a fracture appearance that was more brittle and inter-granular than normal for a fatigue failure. The unexpected appearance of the fatigue fracture surface may simply be the characteristic of material. Comparing the fracture with fatigue test samples concluded the failure mechanism was fatigue.

Finite Element Analysis showed the stress report for various levels developed in shaft and obtained a graph of stress rang(MPa) Vs. fillet radius at shaft corner(mm).It concludes that the pulley shaft has failed due to fatigue mechanism and was a result of improper overhaul. A sharp fillet at the shoulder of shaft where the diameter of changes drastically. Welding carried out during shutdown resulted hardness change at fillet shaft shoulder. The manufactured mechanical parameters stood at their ground and do not intervene in failure however improper service contributed majorly to shaft failure.

Fig-1: Failed pulley shaft [1]

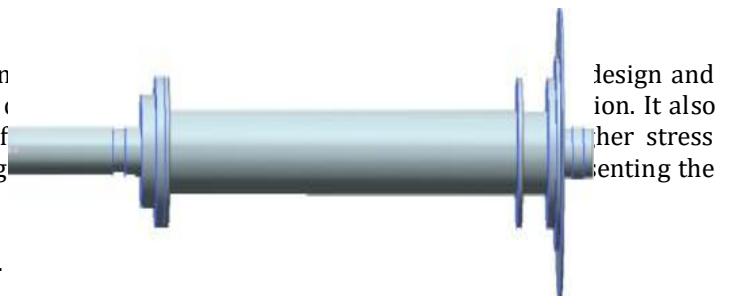
The Material of content of shaft was found to be standard. Average micro hardness, yield strength & tensile strength were 157 HV, 349 MPa, 527 MPa hence the material quality was good and failure was not due to material property. FEA showed the remarkable stress concentration at the shoulder's chamfer 5mm, but the actual radius was 2mm. The higher stress concentration and torsional vibration induced the micro crack's initiation along the chamfer and grew in size due to continuous stress and torsional vibration.

Fig-2: The three-dimensional model of induced draft fan's shaft. [2]

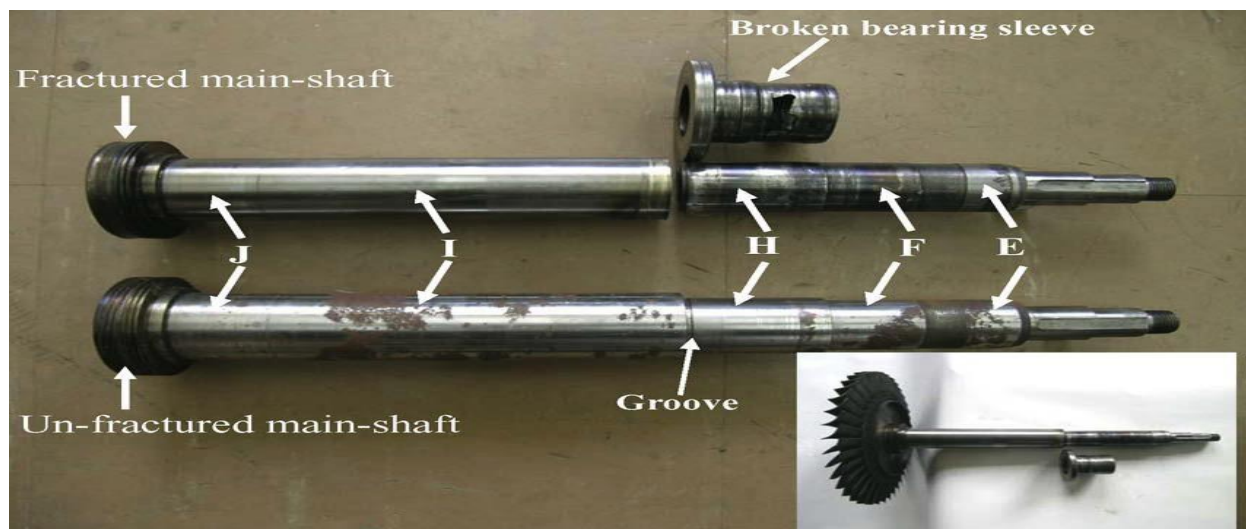
This paper is an analysis of failure of main shaft of locomotive turbo charger. The fracture position is located at a groove between journals with different diameter. The rotating bending fatigue is the dominant failure mechanism of the shafts. Detailed metallurgical analysis indicates that fillet region of the groove had subjected to high temperature. This resulted from the intense friction between the bearing-sleeve and the assisted pushing Bearing, which made the fatigue strength of the fillet region of the groove decrease.

It was worth noting that too short fillet radius increased the stress concentration so high that it facilitated the fatigue cracks to initiate in the fillet region of the groove. It further facilitated the conditions responsible for the rotation-bending fatigue fracture of main-shaft.

Fig-3: Fractured main-shaft and broke bearing sleeve. [3]

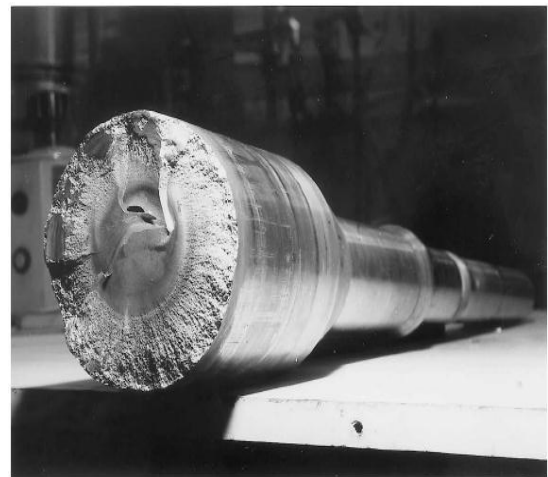
This paper analyses the failure of a river water circulating motor shaft. It includes Fractography, Metallography & Energy dispersive spectroscopy. It also focuses on the various mechanical tests to find out root cause of the failure. Location of the failure surface was not on any fillet, corner or keyway but at 600mm from of the ends of the shaft. Shaft failed after 80,000 operational hours. The characteristics of the fatigue are neatly mentioned. The Fractography was determined by the scanning electron microscopy. It stated that cracks are of inter granular morphology with grains.

Chemical Composition was found to be ok, but the Mechanical Tests taken did not give the satisfactory results. Carpy test was conducted and the shafts impact value did not meet the manufacturer's value.

Fig- 4: Photographs of the failed shaft [4]

Tensile and Hardness tests were not up to the mark. The material of the shaft was Martensitic Steel, thermal analysis was conducted to analyze the root cause of failure. Martensitic steels are susceptible to two types of embrittlement, Temper and Hydrogen Embrittlement. The shaft showed cracks internally first and then on the surface. It was concluded that the shaft failed due to improper thermal treatment. It facilitated temper embrittlement process.

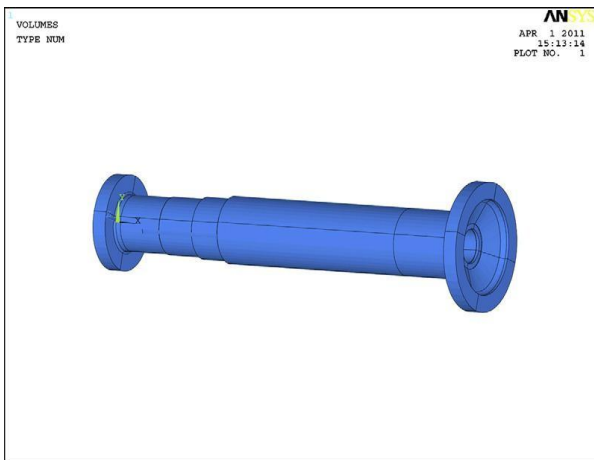
The finite element model of the shaft showed more stress concentration then at critical radius then the limiting values. It was concluded that shaft failed due to the combination of several factor:

- Improper corrosion protection in the region of critical radius.
- High stresses during beginning/end cycle.
- The critical radius could be increased show that stresses are distributed over larger area.

Fig- 5: 3D shaft model [5]

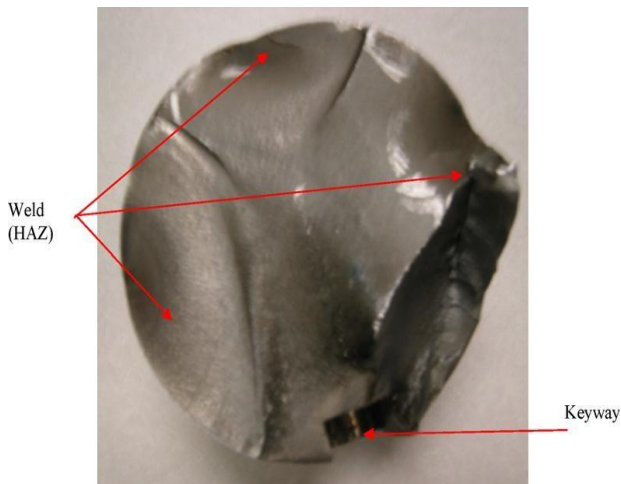
Fig-6: Failed shaft with heat affected zone (HAZ) and keyway. [6]

The microstructure shows that the grains were distributed unevenly along the entire austenite matrix, the face is referred to as delta ferrite stringers. This facilitates blocking of inter granular cracks. However, if temperature during welding reaches high value, it becomes sensitized and lose this properties. Electron microscope shows that inter granular cracks were centered at the weld location. Further calculation revealed that stress concentration at the weld plugs was higher than the standard design. The fillet corner was too sharp to withstand the stress concentration for longer duration. At percent speed 99 safety factor with stress concentration was 1.001. The failures causes were more allied to welds. Because of vibration issue of loosely fit shaft weld plugs were used which resulted in stress concentration.

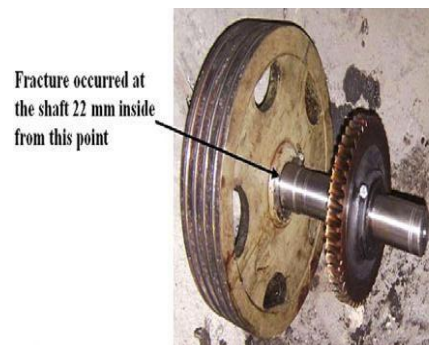
During the stress analysis, minimum and maximum shear stresses are investigated at the fracture surface. Total shear stress was found to be 25.7 MPa. Visual examination concluded that the surface from the keyway ground to the keyway side surface was approximately perpendicular hence radius of curvature was negligible.

Fig- 7: Failed elevator drive shaft. [7]

By taking the shaft geometry into consideration notch effect is calculated. By determining the Endurance Limit and Equivalent stress, Fatigue Safety of Factor is achieved to be 1.05 which is quite low. It was concluded that by increasing the radius of the curvature of keyway the stress could be diminished at high value. By using the FEM stress intensity and concentration are shown.
